UTAH AERONAUTICS CONFERENCE  
2023

# **Moving to Mastery: Pilot and Mechanic Training**

**Ted Chester, Randy Chesley,  
and Stephen Snyder**

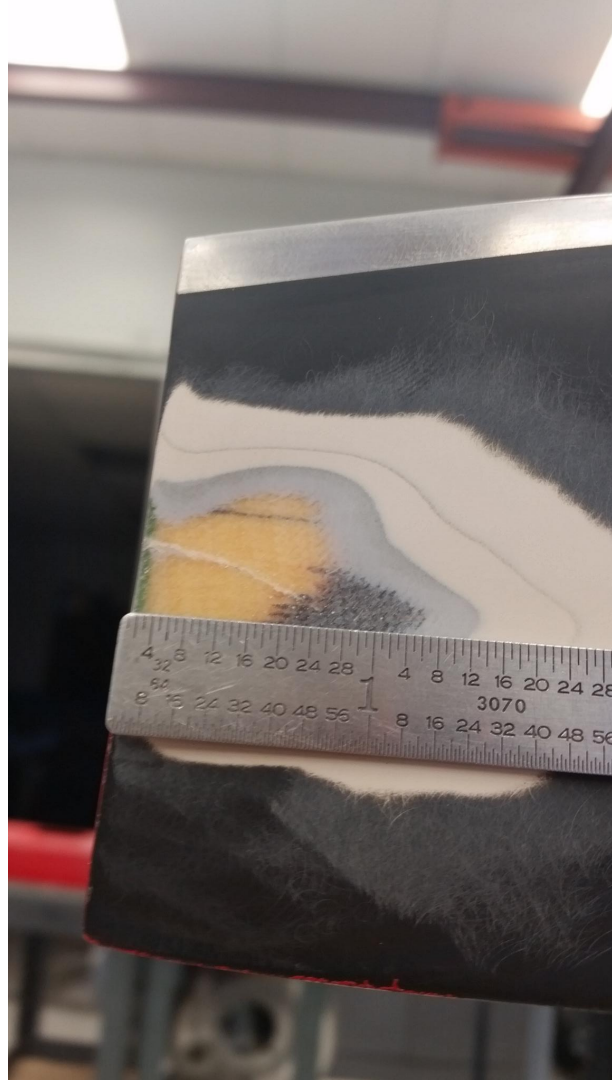
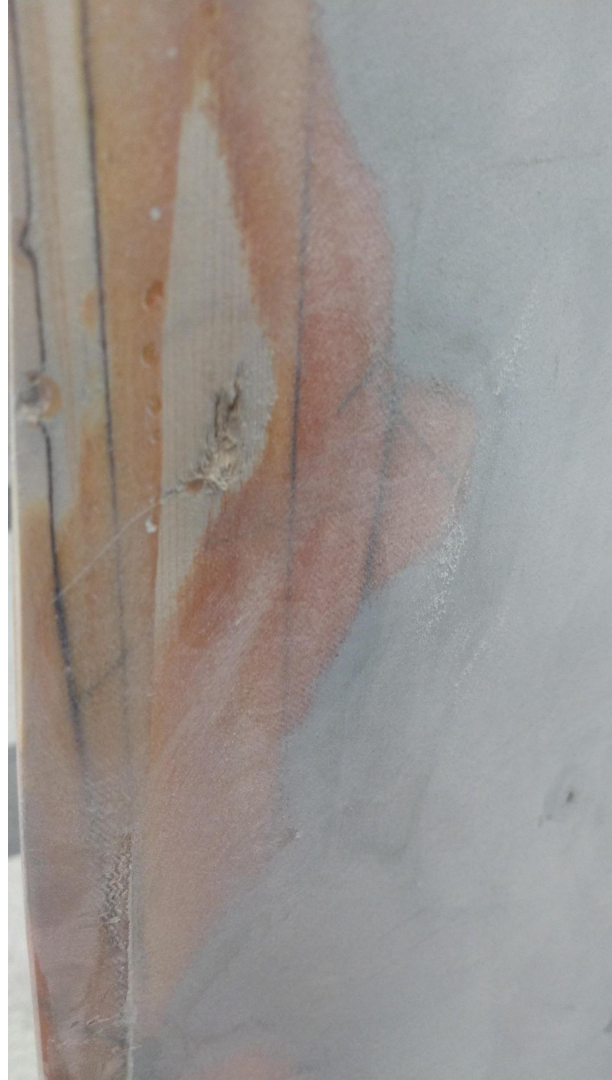
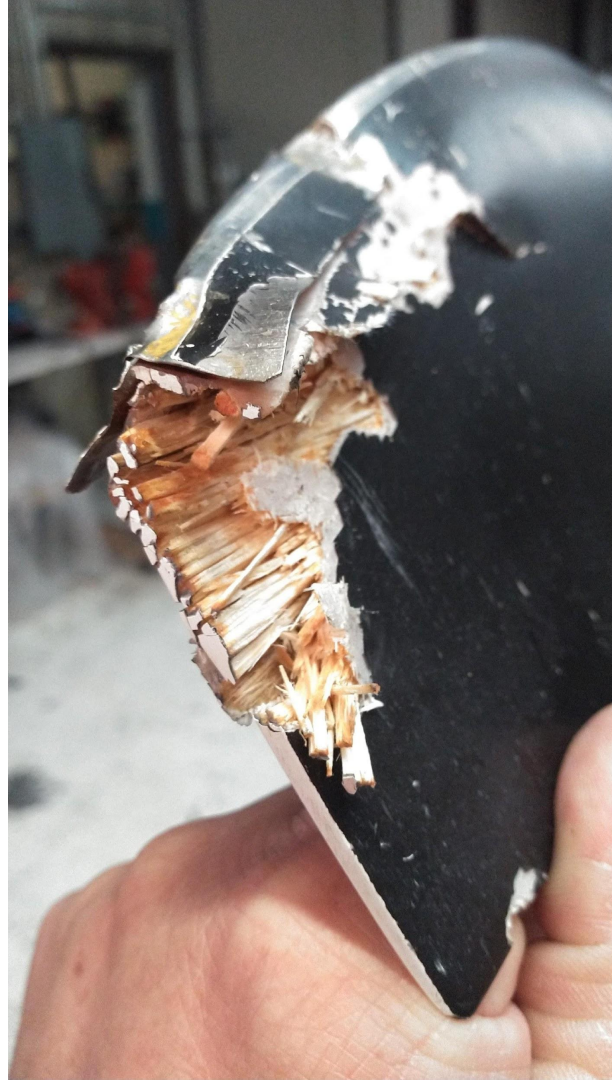
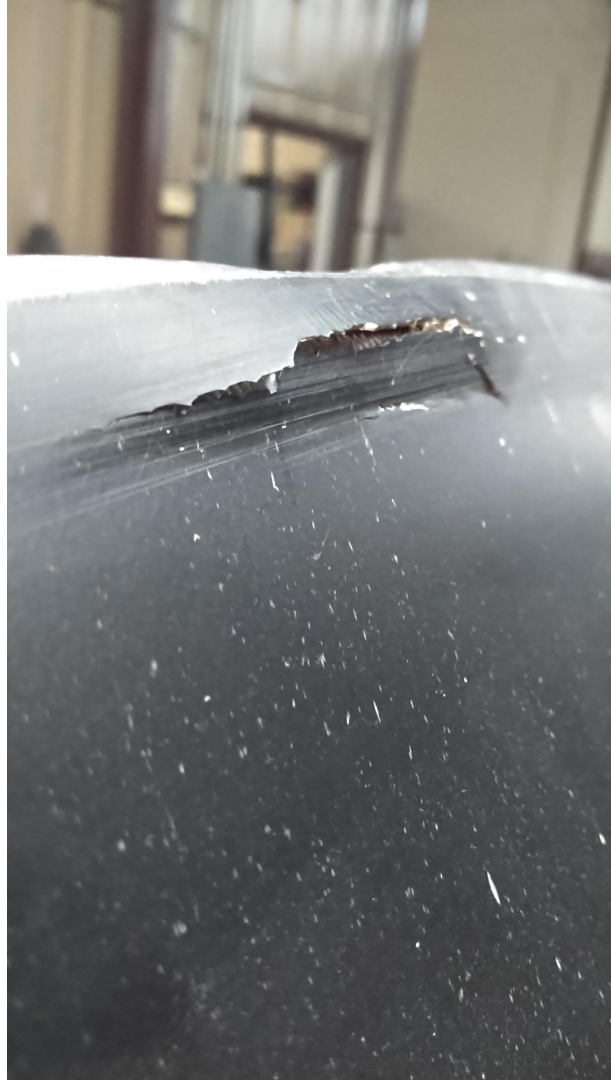
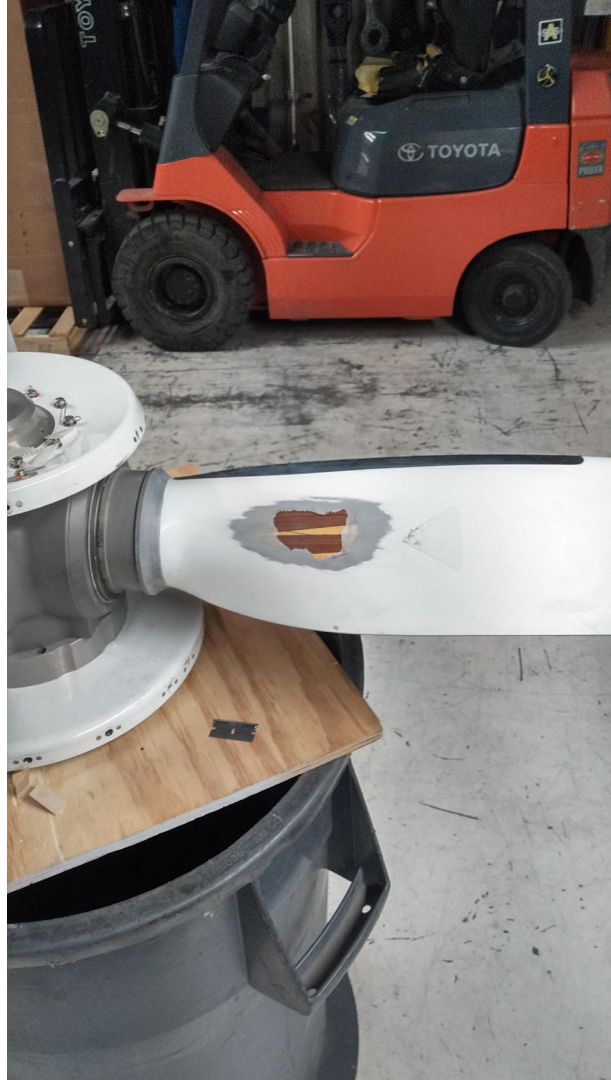
- As Composite blades become more common, it has become common to see props with stress cracks in the paint.
- In Composite props the remedy is removing all paint and observing the primer for damage.
- If damage is found in primer layer, all primer will need removal and the fiberglass and carbon fiber layers will need to be inspected for cracks.
- If damage is found in fiberglass and carbon fiber layers affected areas need to be removed and composite layers below need to be inspected for cracks.
- Cracks or damage in any composite layer rejects blade or needs factory overhaul.

MT-PROPELLER \* D94315 STRAUBING \* TELEFON ORDNUNG \* TELEFON ORDNUNG \*

MTV-15-B/210-58
